Inspection Date 12/22/87 David Barnawski  
 Report Date 1/3/88

File No 113-158-104, 0812

CALIFORNIA REGIONAL WATER QUALITY CONTROL BOARD—  
LOS ANGELES REGION

January 6, 1988

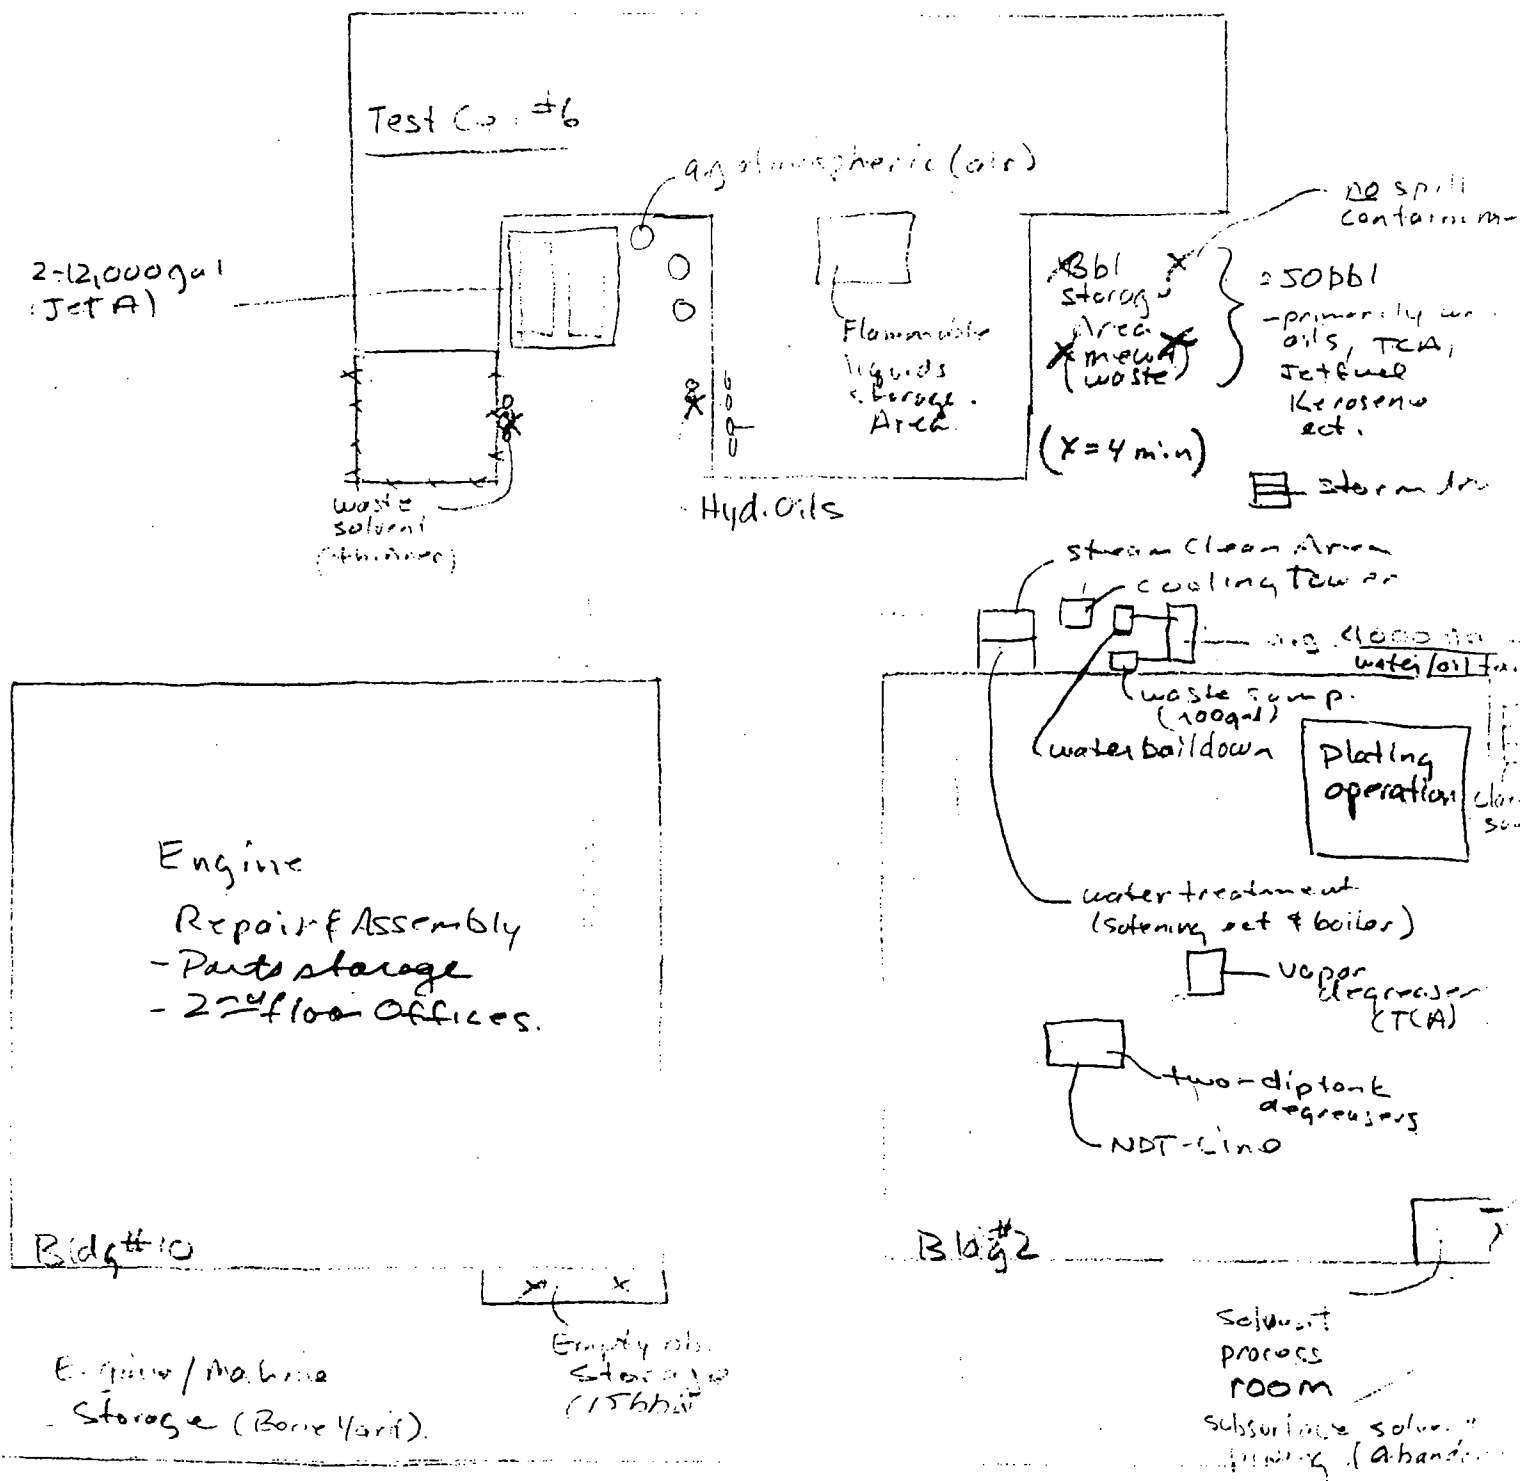
Figure 1 - General Site Plan

1. Barrel storage area (wood frame product) - asphalt concrete generally in good condition, all bbls covered and waste barrels correctly labeled and dated. However entire area does not have a berm to contain spills or control surface water runoff. (250 bbls)
2. Two (2) other locations near v.g tank were waste thinner and hydraulic oils are stored outside asphalt in both areas cracked, visible spills and distressed. (2, (4 bbls)

3. The water (hydraulic oil area where a.g. 4,000 gallon tank is currently located) used to be below ground in the same area. Mr. Lora stated that soil testing has been completed (Agency unknown) subsequent to removal and retrofit above ground. Results to be soil sampling / testing to be submitted for review & evaluation. Oil pump in this same area replaced a 1 g. ag.
- 4). Solvent process room where underground piping leads to lockers facility should be investigated. Details on previous work and any problems disclosed.
- 5) Empty barrel storage area (15 bbls) was generally clean no obvious spillage apparent. However storage on asphalt in poor condition many cracks visible (Rain the day before inspection).

- 1) Soil Test findings should be completed at the least designated on Fig 1. Details pertaining to v.g. water process tank provided with soil test results

evaluate if additional such testing needed
